# *Operation* **UPSHOT-KNOTHOLE** NEVADA PROVING GROUNDS

EFFECTS OF AN ATOMIC EXPLOSION ON TWO TYPICAL  
TWO-STORY-AND-BASEMENT WOOD-FRAME HOUSES

FEDERAL CIVIL DEFENSE ADMINISTRATION  
WASHINGTON D.C.

Report to the Test Director

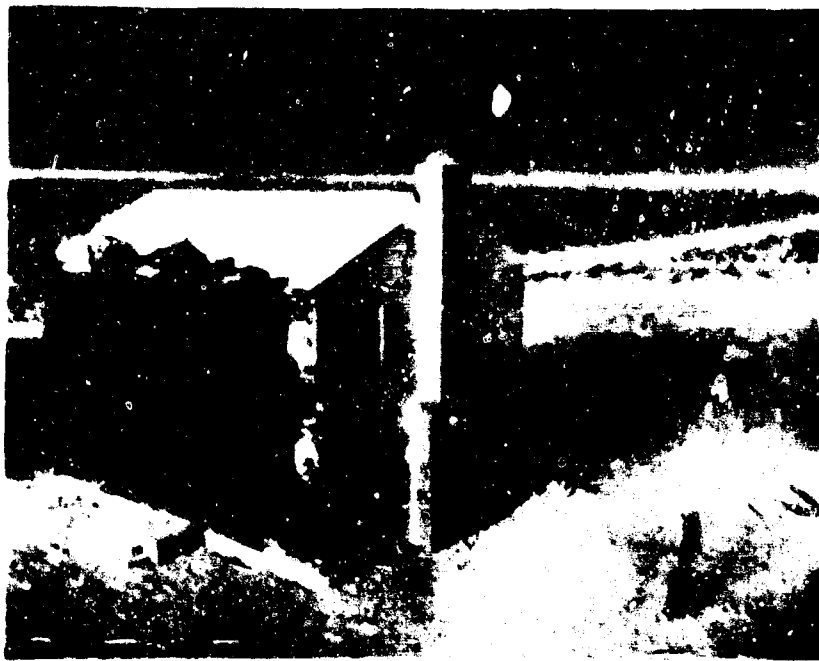
Fig. 1.3—House at 3500 ft,  $1\frac{18}{24}$  sec after detonation. The front of the house is almost obscured by smoke.

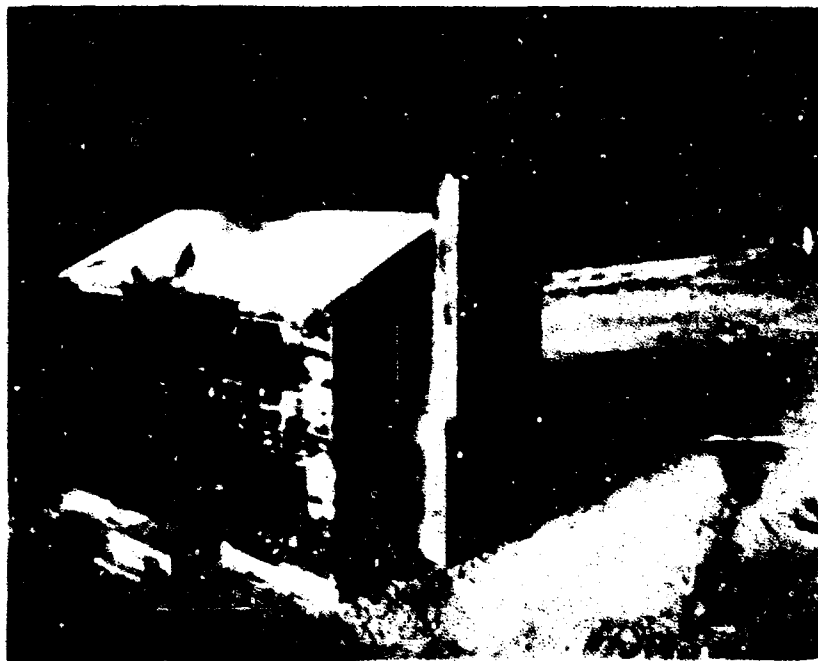
Fig. 1.4—House at 3500 ft,  $1\frac{18}{24}$  sec after detonation. The smoke is virtually gone.

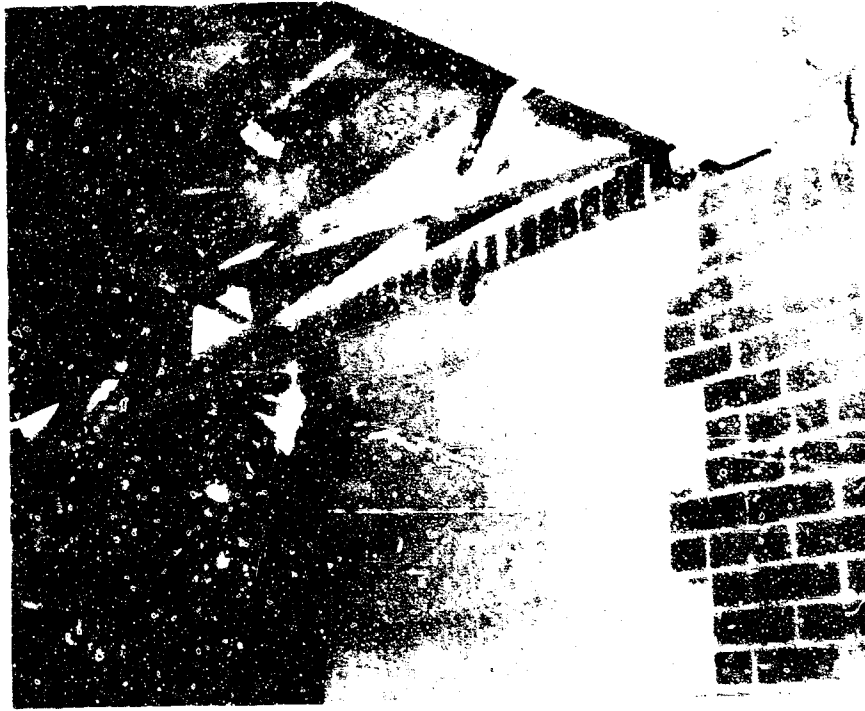
The first-story stud walls were disintegrated by the blast and allowed the second story to drop on the first floor. Most of the living-room floor sagged into the basement due to broken joists. The first-floor framing system moved, in general, as a unit toward the rear of the house, about 2 ft at the right side (looking at the front of the house) and 1 ft at the left (see Fig. 2.46 which shows the distance that the first floor moved at the basement corner-room shelter). The ends of the 6- by 8-in. wood girders were pushed through the masonry foundation wall at the rear of the house, as shown in Figs. 2.47 and 2.48. The ends of the wood girders at the front of the house moved off their bearings (Fig. 2.49) a maximum distance of 1 ft 3 in., and the girders cantilevered from the front pair of pipe columns. Base and cap plates of the pipe columns leaned to the rear but did not overturn.

Fig. 2.49—Front ends of the wood girders.
